Miami Air International  
Jacksonville, Florida  
May 3, 2019  
DCA19MA143

**NATIONAL TRANSPORTATION SAFETY BOARD  
WASHINGTON, D.C.**

MIAMI AIR LIFE RAFT DEPLOYMENT FAILURE INVESTIGATION REPORT

**ENGINEERING DOCUMENT NUMBER 4890****INVESTIGATION REPORT  
Miami Air Life Raft Deployment Failure****Life Raft Part Number D23940-117  
Serial number 5625A****Revision A**

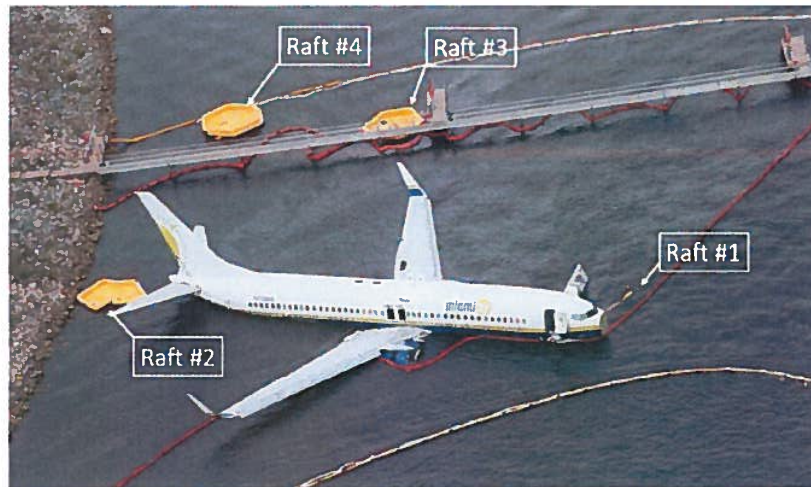
Figure 1  
Life Rafts after the Event

Figure 1, an overview of the aircraft the day after the event, shows all four life rafts. The life raft that failed to inflate is visible underwater at the front of the aircraft, on the left side, where it had drifted due to the river current. This life raft, labeled Raft #1 in the photo, is a 46 person Air Cruisers life raft with part number D23940-117 and serial number 5625A. This life raft is the subject of the investigation by the NTSB Survival Factors Group, and the subject of this report.

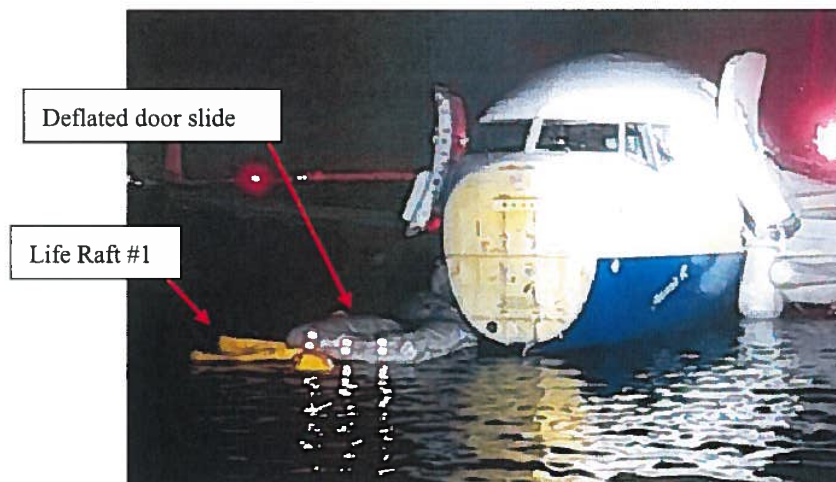
Figure 2  
Life Raft #1 in the Water

The photos in Figures 2 and 3 show the life raft and its carrying case in the water near the right hand forward door after the event.

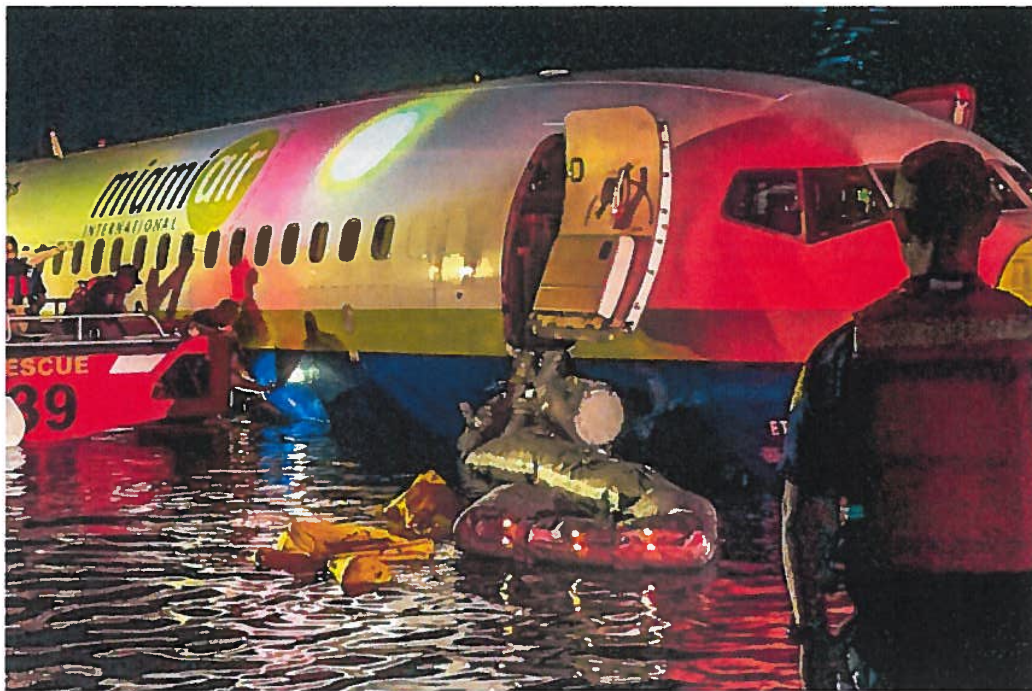
Figure 3  
Life Raft #1 and Deflated Evacuation Slide at RH Forward Door

Based on the official witness statements, a flight attendant opened the right hand forward door during the emergency evacuation. The evacuation slide on this door inflated, but then immediately deflated. The flight crew then deployed the subject life raft through this door over the deflated evacuation slide, but the life raft failed to inflate.

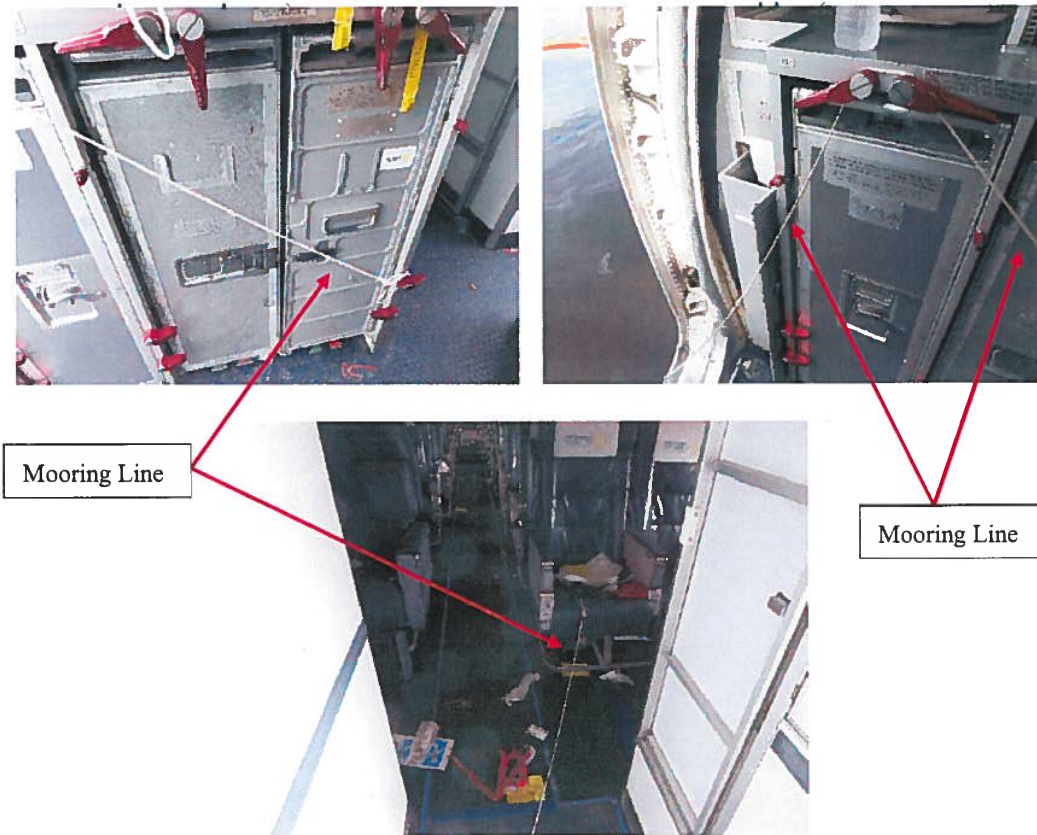
Figure 4  
Life Raft Mooring Line Secured to Aircraft

The mooring line for Life Raft #1 was secured to the aircraft, which is the initial step in the deployment process. The NTSB Survival Factors inspection team found the end section of this mooring line wrapped around several latches for the galley carts in the galley adjacent to the RH forward door. The snap hook at the end of the mooring line was attached to the seat belt buckle at seat 1C in the first row of seats behind the

galley (see photos in Figure 4). This section of the mooring line had either separated from the life raft or had been cut off following the event.

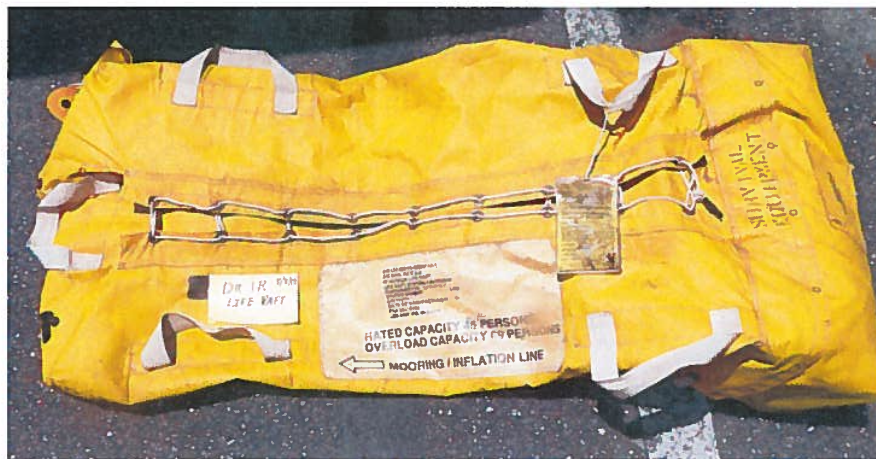
Figure 5  
Life Raft #1 Carrying Case

The NTSB field response team retrieved the life raft and carrying case from the river. The carrying case, shown in Figure 5, was unremarkable with no unusual damage or other findings of potential interest.

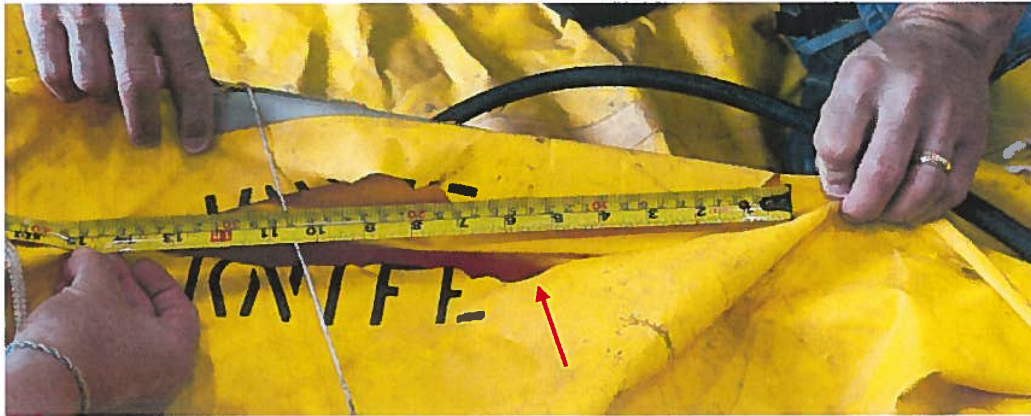
Figure 6  
14 ½ inch Tear in Airholding Tube

Several tears were found in one of the airholding tube assemblies. A 14 ½ inch jagged tear, with adjacent fabric chafing damage, was found at the “KNIFE” stencil,

The tears in the life raft tube assemblies are believed to be a consequence of the retrieval effort, since the sunken life raft had drifted under the aircraft in an area with known damage to the aircraft understructure and front gear.

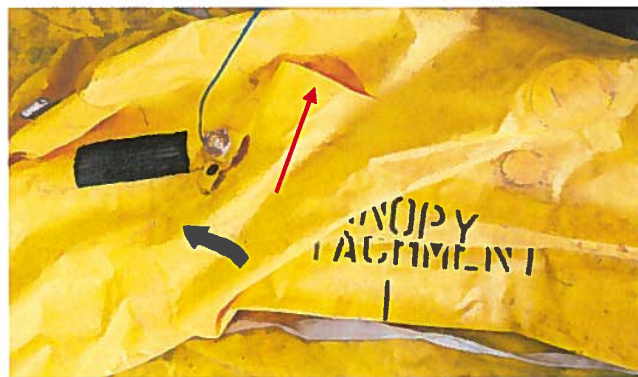
Figure 7  
6 inch Tear in Airholding Tube

as shown in Figure 6 below. A second tear, 6 inches in length, was found on the opposite side of the life raft tube assembly, near a locator light as shown in Figure 7.

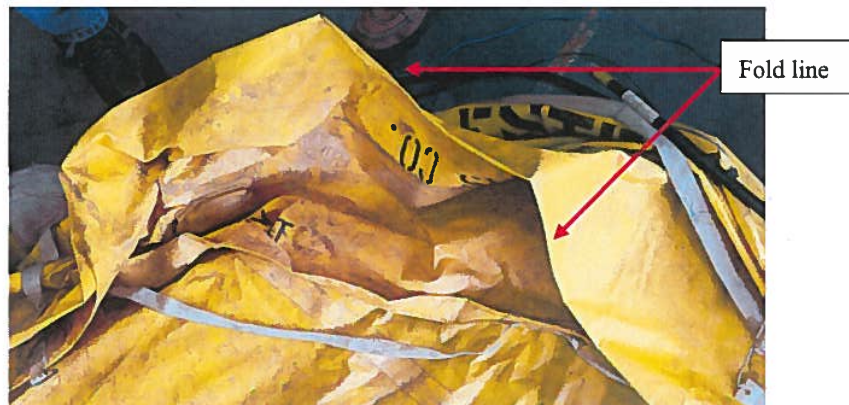
Figure 8  
Fold Lines Still Evident

Distinct fold lines were still evident in the life raft tube fabric at various locations, indicating that these areas had not inflated during the attempt to deploy the life raft. An example is shown in Figure 8.

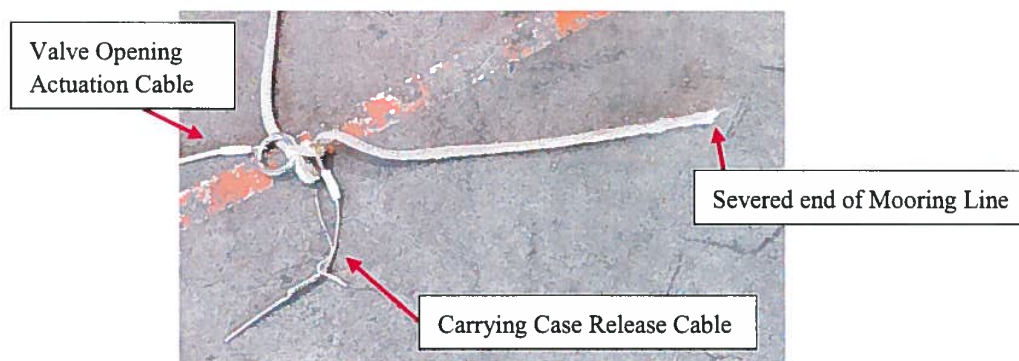
Figure 9  
Severed Mooring Line

The mooring line was severed but was still attached to the life raft. The severed end of the mooring line is shown in Figure 9, with the valve opening actuation cable and carrying case release cable still attached. There were several locations on the mooring line with chafing damage.

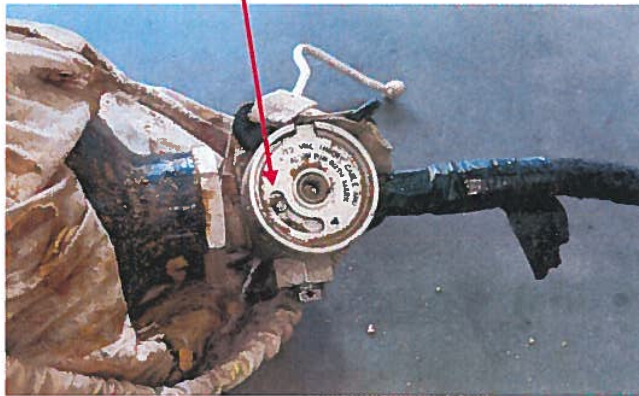
Figure 10  
Fully Open Inflation Valve #1

There are two independent inflation gas reservoir and valve assemblies on this life raft (one for each tube assembly on the life raft). Both inflation valves were found in the fully open position with the inflation cables extracted, which is the expected condition following a life raft deployment (see Figures 10 and 11). Both pressure gages indicated that the gas reservoirs were empty.

Valve Position Indicator: Full Open Position

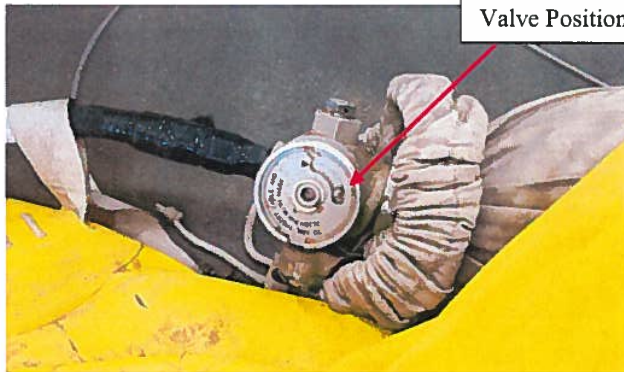
Figure 11  
Fully Open Inflation Valve #2

Valve Position Indicator: Full Open Position

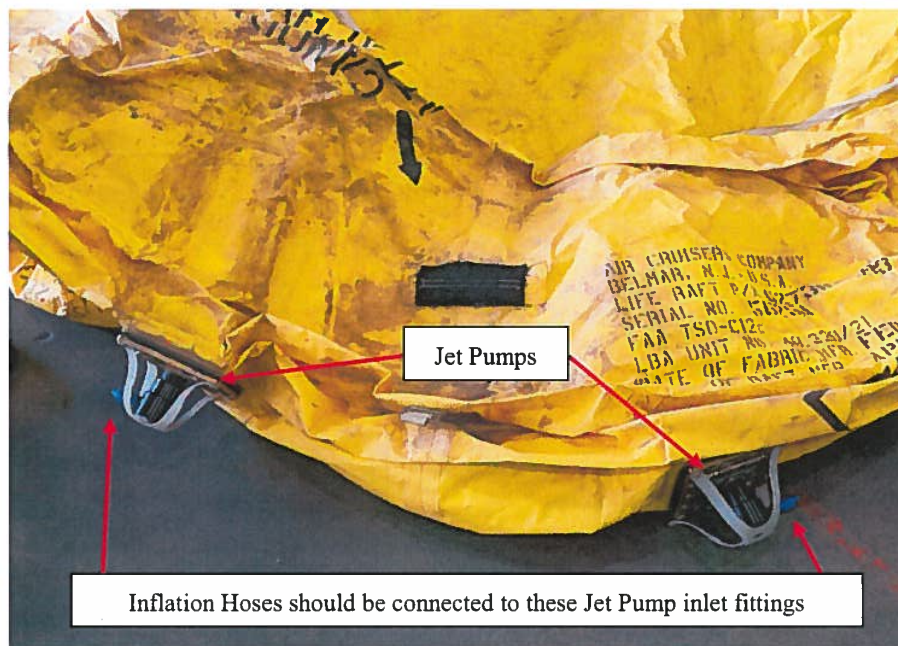
Figure 12  
Inflation Hoses Not Connected to Jet Pumps

Two inflation hoses connect the outlet port of each reservoir and valve assembly to a jet pump. These inflation hoses were routed along the outside of the life raft in accordance with the assembly procedures in the applicable CMM. However, these inflation hoses were not connected to the jet pumps that supply the high-pressure inflation gas and ambient air to the air holding tube structures as shown in Figure 12.

In this case, both inflation valves opened as expected, and all of the inflation gas was discharged from the reservoirs. However, since the inflation hoses were not connected to the jet pumps, all the inflation gas escaped and the life raft was not able to inflate.

The subject life raft subject failed to inflate due to a failure to connect the inflation hoses to the jet pumps that supply inflation gas and ambient air to the life raft. The life raft deployed as expected, but could not inflate due to the escape of inflation gas through the disconnected inflation hoses.

Proper focus on the assembly procedures is necessary to minimize the risks associated with human factors. The instructions in the CMM and folding procedure are sufficiently detailed to ensure proper installation.

The subject life raft should be removed from service due to its lengthy exposure to water and damage associated with the incident.

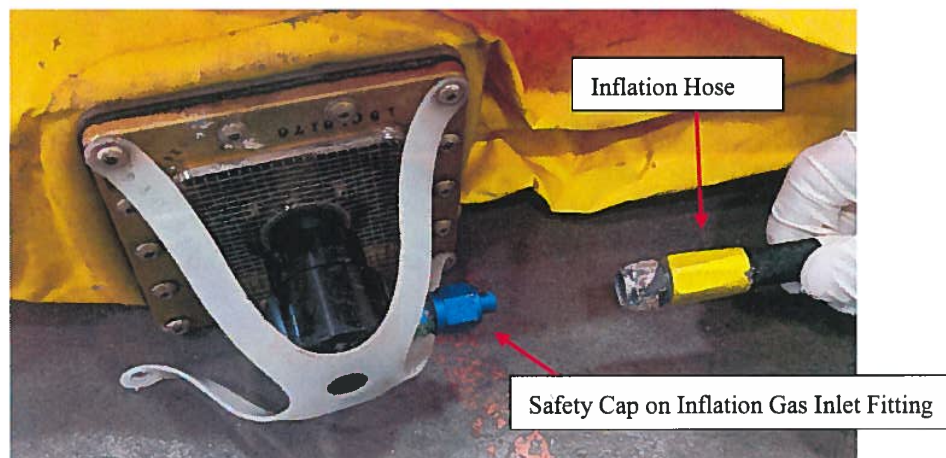
Figure 13  
Jet Pump #1 Inflation Gas Inlet Fitting Capped

A safety cap was installed on the inflation gas inlet port on each jet pump as shown in Figures 13 and 14. This is the location where the inflation hoses should have been connected. Consequently, none of the inflation gas stored in the reservoirs would have reached the life raft assembly when the life raft was deployed.

The installation of a safety cap on the jet pump inflation gas inlet would allow the life raft to be leak tested or repaired after removal of the inflation hoses and reservoir and valve assemblies for inspection and testing of these components per the CMM. The tear down/inspection report from American Southeast from the last maintenance on the life raft noted that the reservoir had been hydrotested, and the inflation hose had

been pressure tested, which requires the removal of these items from the life raft. This may be the explanation for the installation of a safety cap on the jet pump gas inlets.
